BUENA VISTA COALITION (BVC)

SURFACE WATER MONITORING PLAN

August 2014

Buena Vista Coalition

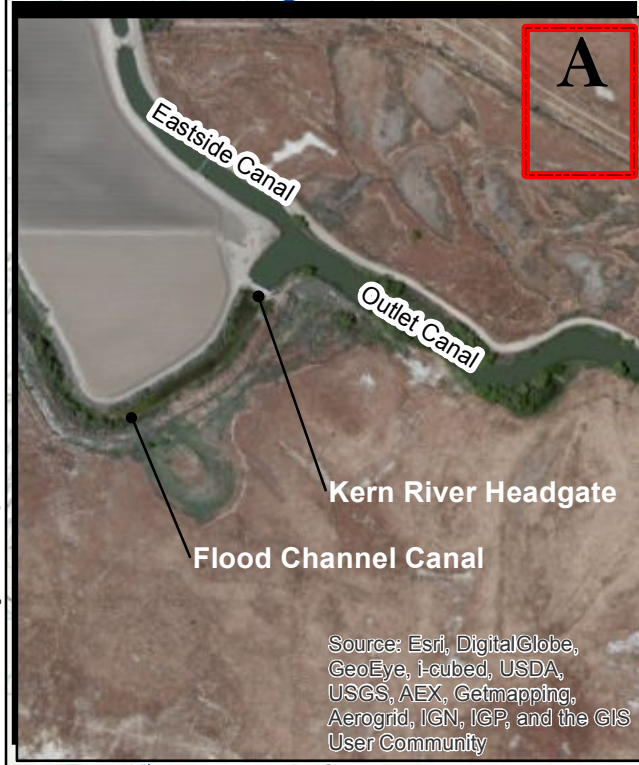
Fig: 2A Kern River Flood Channel Canal Headgate

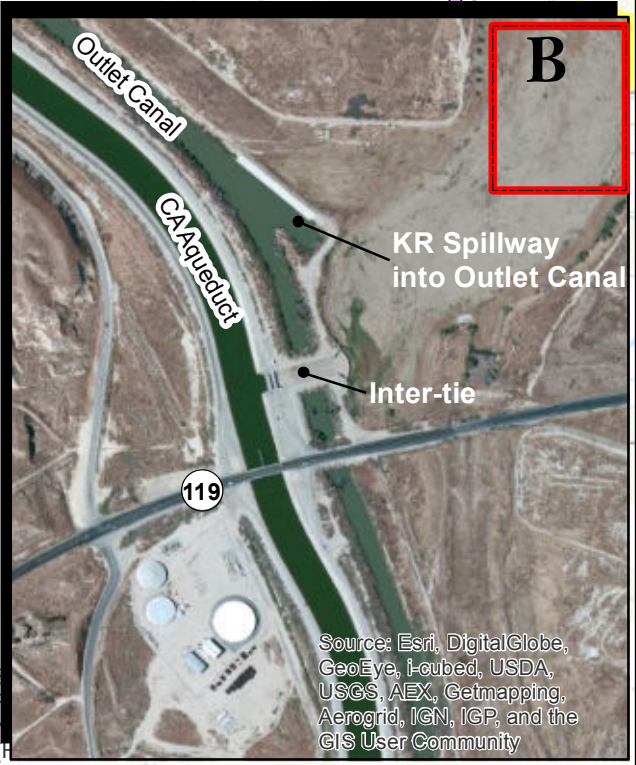
Fig: 2B Kern River- State Aqueduct Inter-tie

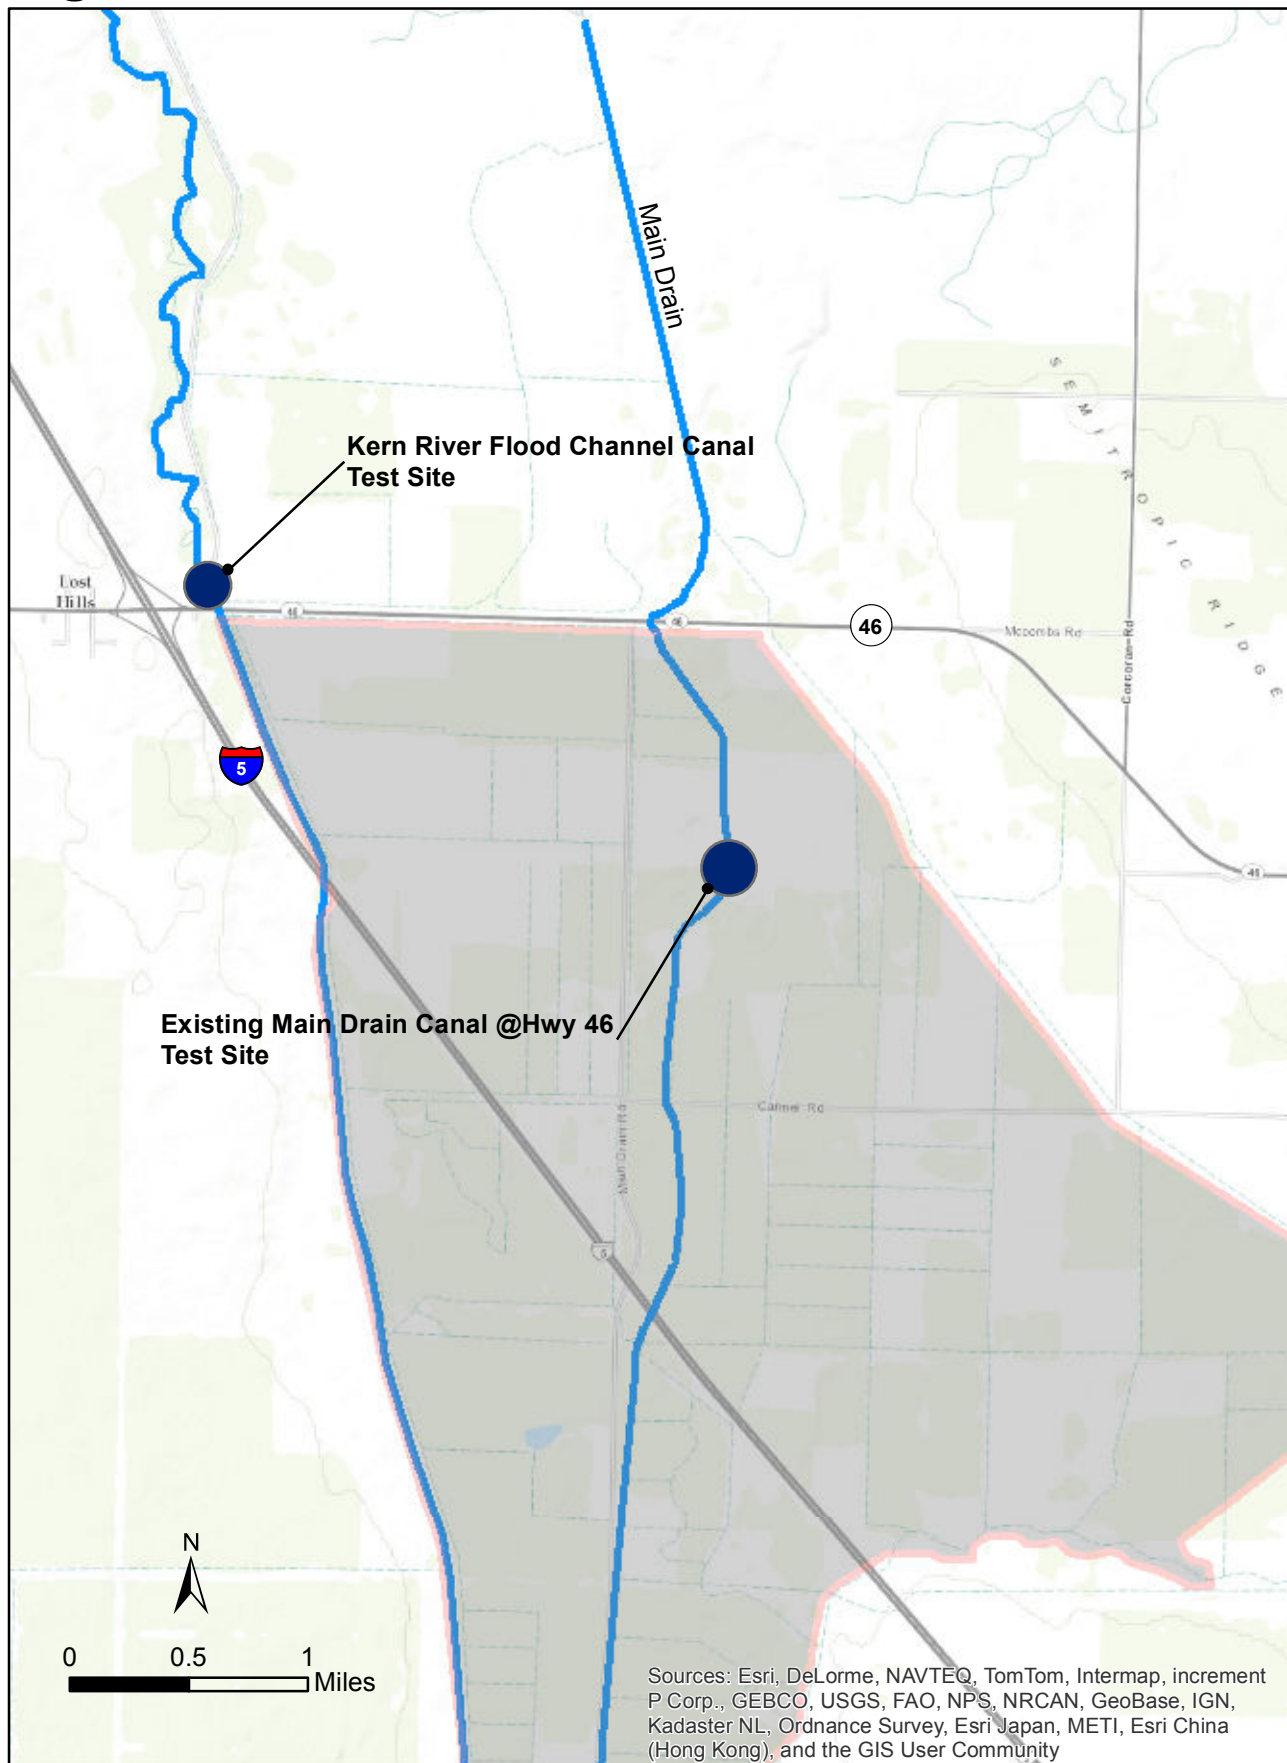
Fig: 4 Ephemeral Test Sites

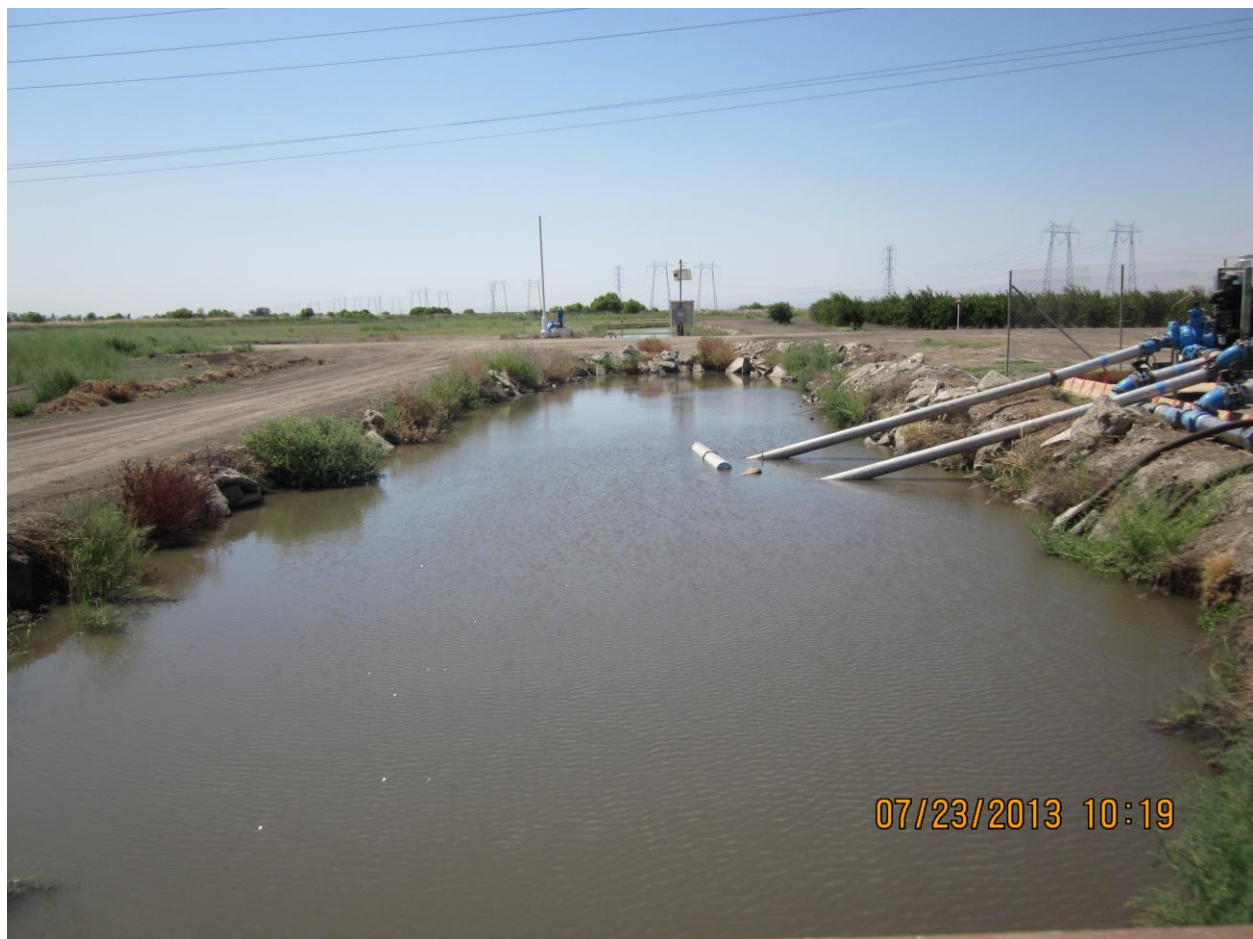
Main Drain Canal looking south towards Highway 46 sampling location

Both of these pictures show the high flow associated with flows to the Refuge, and not the nominal flows which have become routine in the north end of the Main Drain Canal.

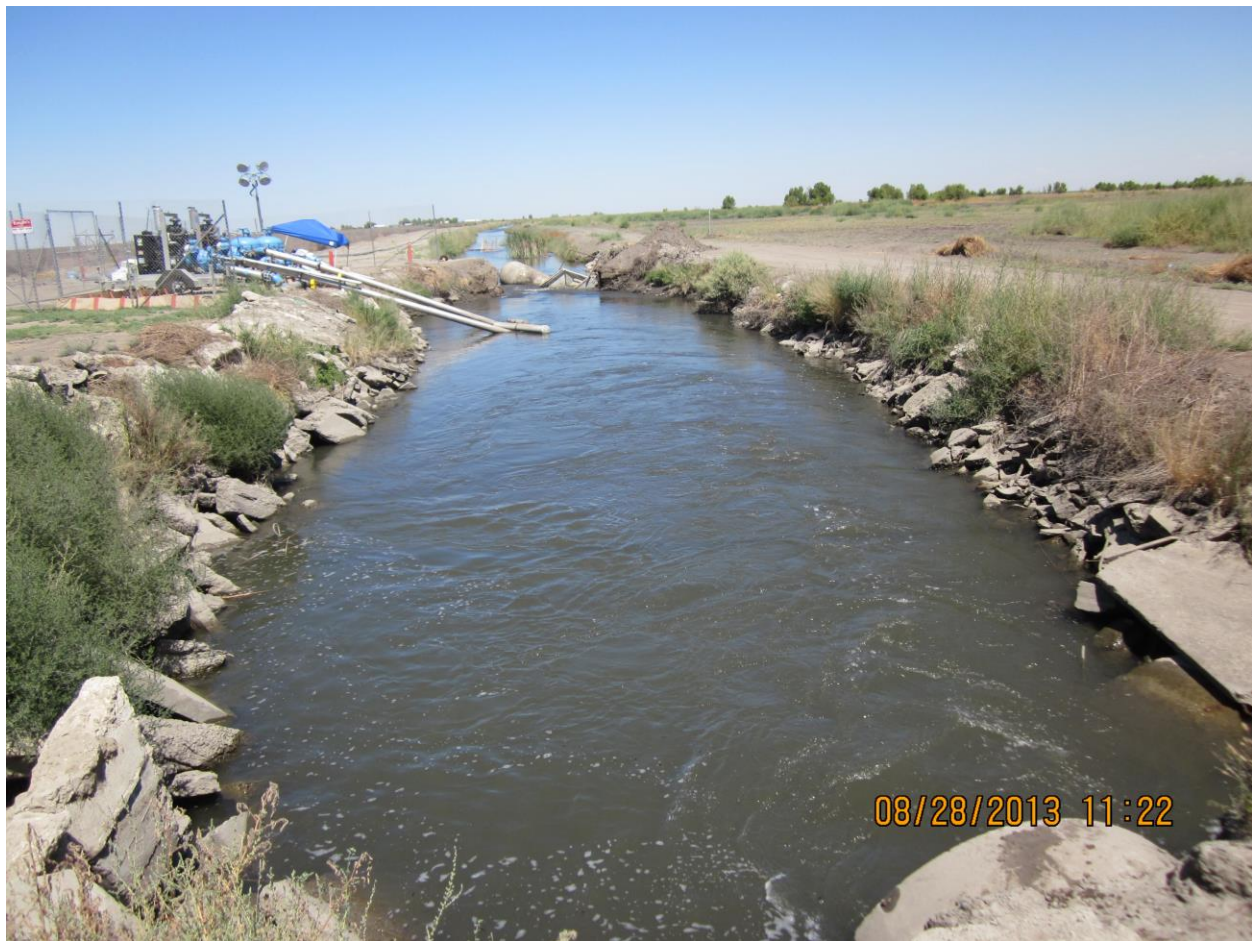
Main Drain Canal Highway 46 Sampling Location looking north
